MARINE POLLUTION SURVEILLANCE REPORT

Analysis Provided by: The National Oceanic and
Atmospheric Administration/National Environmental
Satellite, Data and Information Service (NOAA/NESDIS)

REPORT DATE: OCTOBER 22, 2011

Destroyed Taylor Platform :
[28°56'9" N / 88°58'12" W]

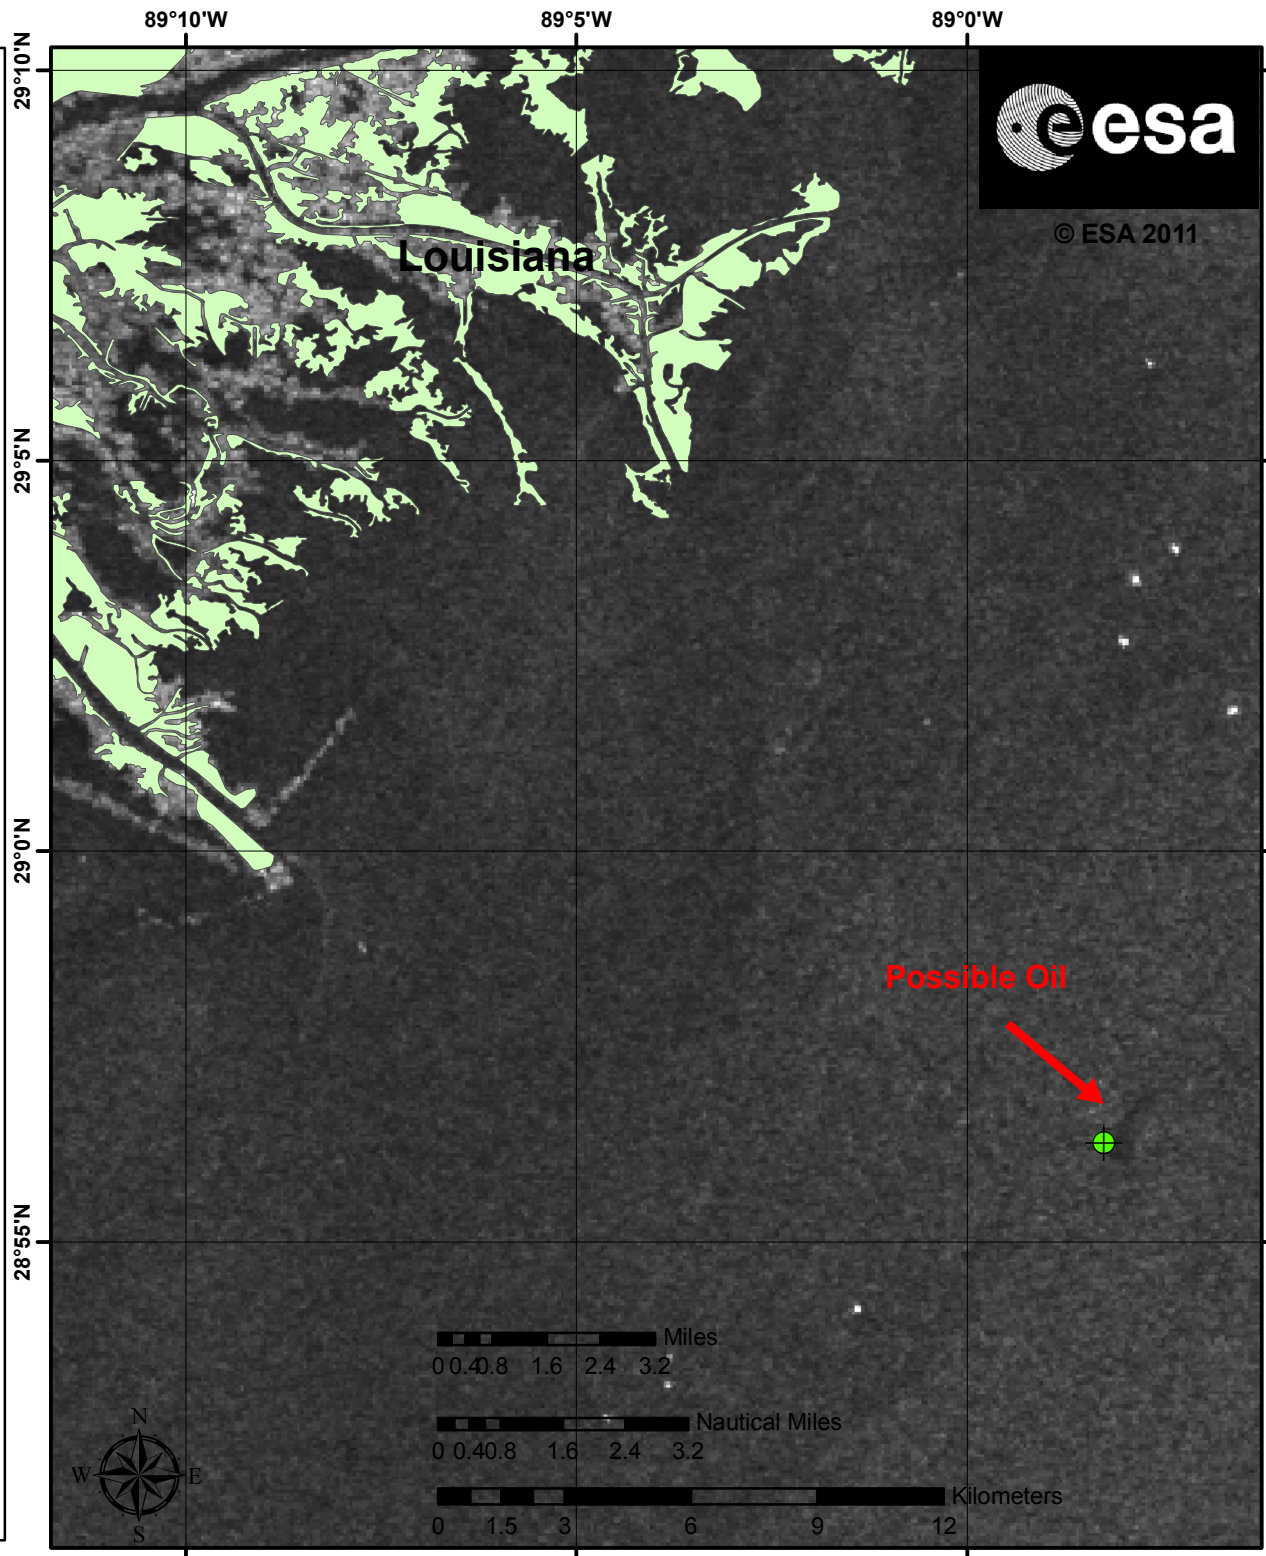
Suspected oil slick seen originated from the Destroyed
Taylor Platform. This slick extends about 1 mile from the
platform.
