MARINE POLLUTION SURVEILLANCE REPORT

REPORT DATE: NOVEMBER 02, 2011

Destroyed Taylor Platform :
[28°56'9" N / 88°58'12" W]

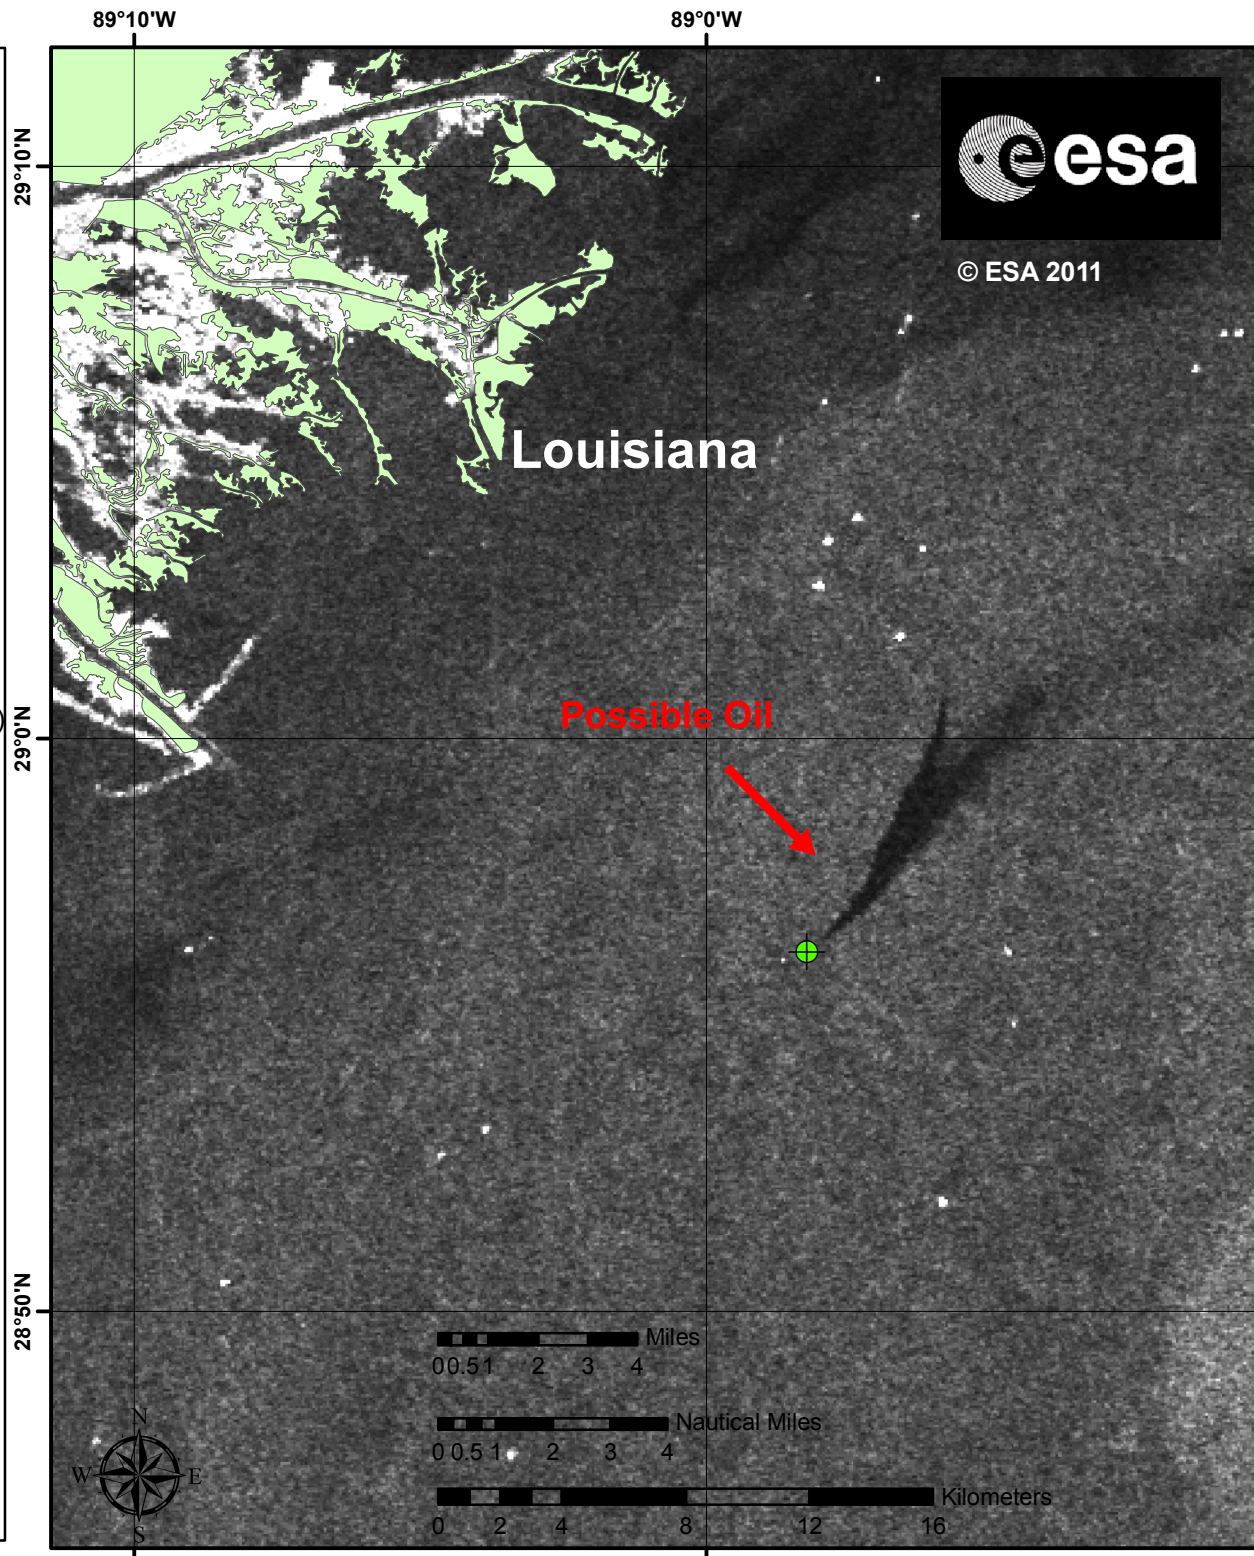
Oil slick extending nearly 7 miles northeast and
connected to Destroyed Taylor Platform. Oil may extend
farther to the northeast of outlined area but it thins out
and has a lower confidence factor
