MARINE POLLUTION SURVEILLANCE REPORT

Analysis Provided by: The National Oceanic and
Atmospheric Administration/National Environmental
Satellite, Data and Information Service (NOAA/NESDIS)

REPORT DATE: June 7, 2011

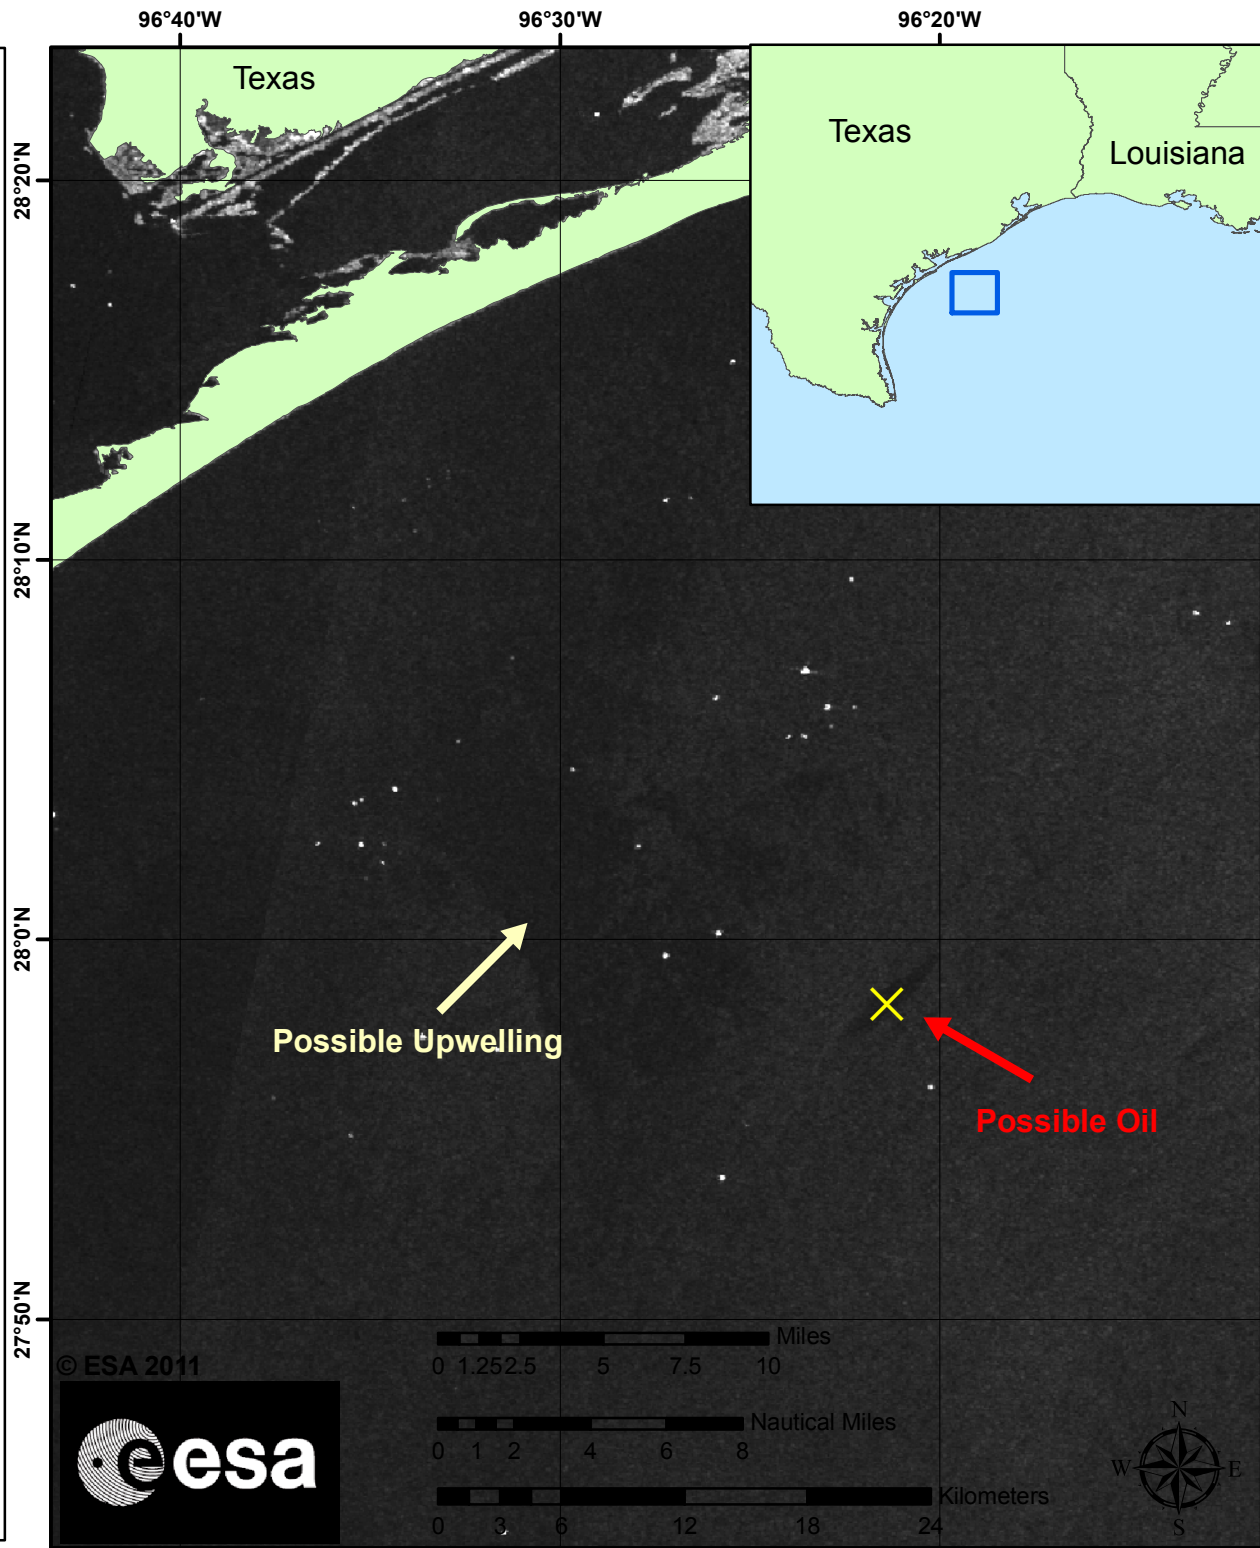
Center Point of Oil Slick:
[27°58'16" N / 96°21'23" W]

REMARKS: Suspected oil slick located approximately 48 miles south-southeast of Port Lavaca, TX. This slick is 3.5 miles long and 0.5 miles wide and appears to have originated from the northeast where the slick is the thinnest and has spreaded out in the southwest direction. There is no point source that can be directly tied to the suspected slick but there are many oil platforms in the vicinity.
