MARINE POLLUTION SURVEILLANCE REPORT

Analysis Provided by: The National Oceanic and
Atmospheric Administration/National Environmental
Satellite, Data and Information Service (NOAA/NESDIS)

REPORT DATE: APRIL 25, 2012
REPORT TIME: 1900Z (1400 CDT)
ANALYST: VOGT

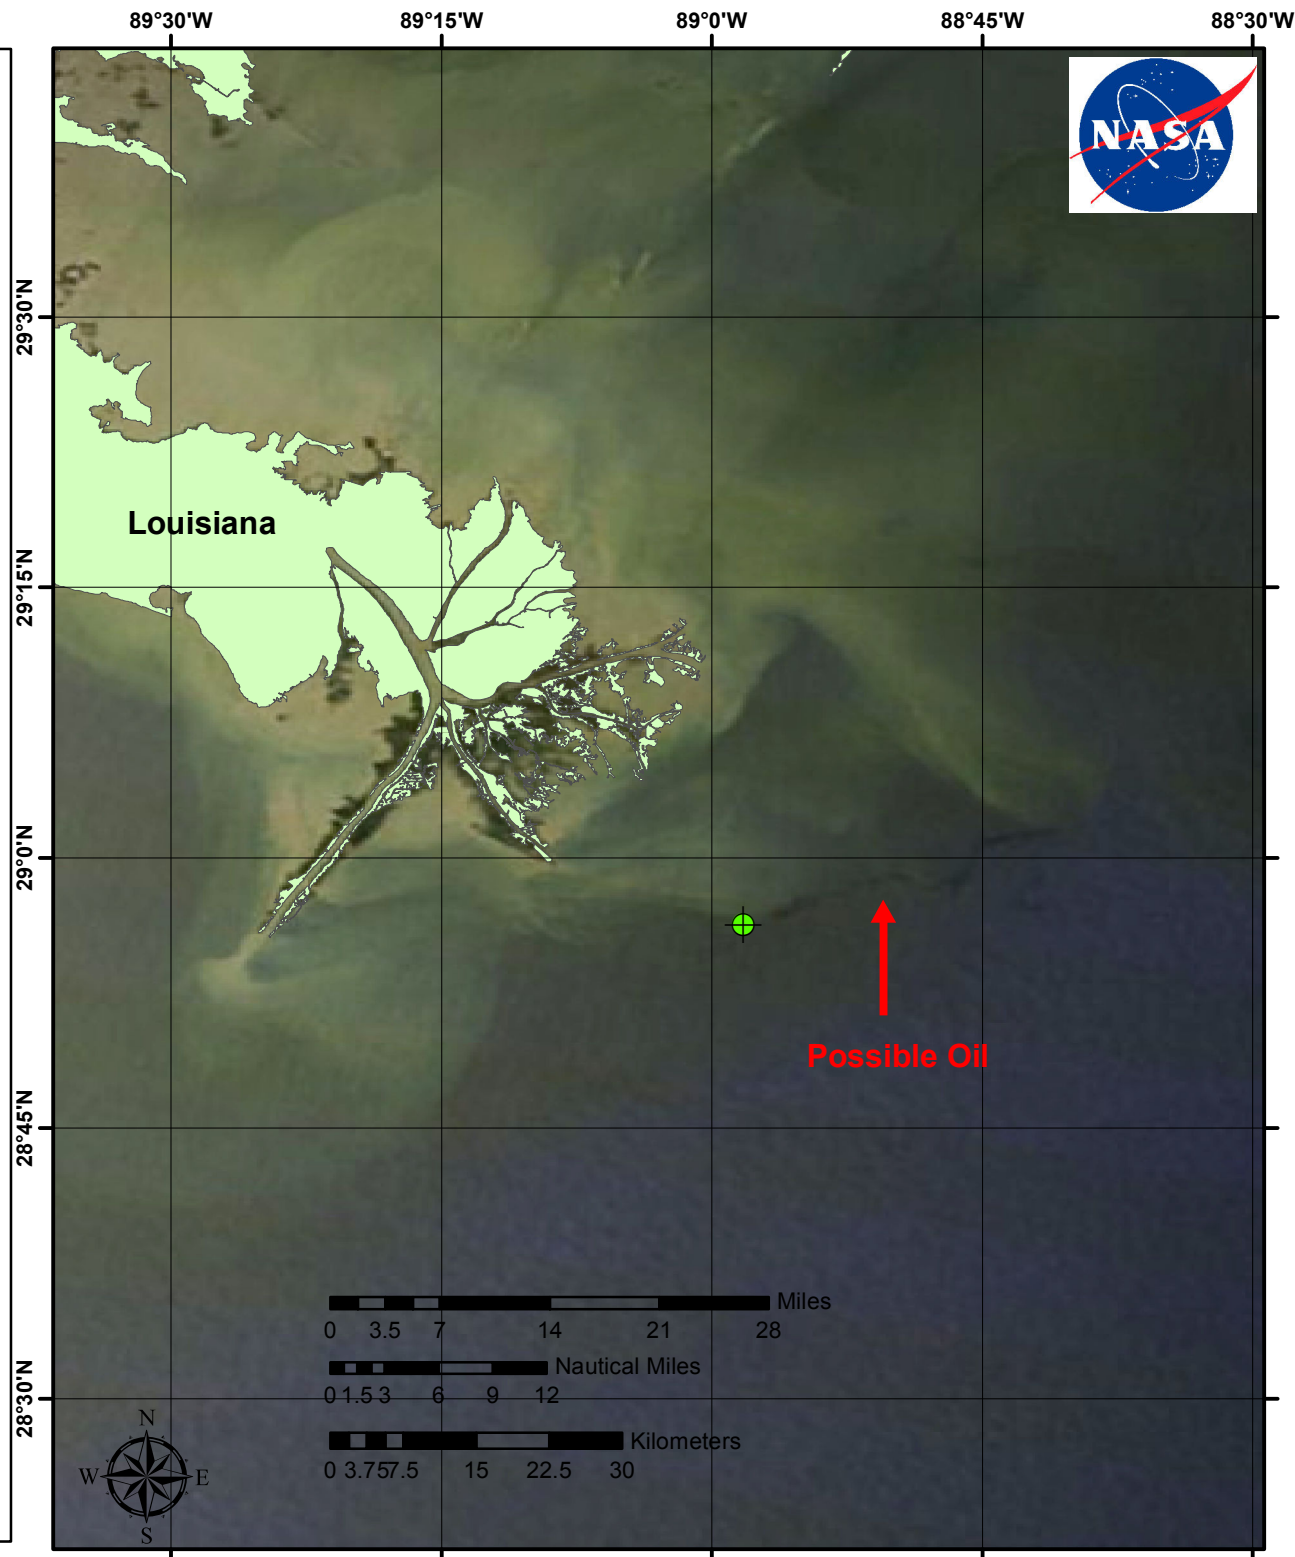
Destroyed Taylor Platform :
[28°56'9" N / 88°58'12" W]

A suspected oil slick can be seen originating from a
known leak source (Destroyed Taylor) near the Bird's
Foot of Louisiana. The slick extends to the east-
northeast about 17 miles and is less than a mile wide.
