MARINE POLLUTION SURVEILLANCE REPORT

Analysis Provided by: The National Oceanic and
Atmospheric Administration/National Environmental
Satellite, Data and Information Service (NOAA/NESDIS)

REPORT DATE: SEPTEMBER 28, 2012
REPORT TIME: 2100Z (1600 CDT)
ANALYST: TURK

DATA SOURCE: LANDSAT-7
MODE: Multispectral
RESOLUTION: 30 meter
IMAGE DATE/TIME: 9/27/2012 1622Z (1122 CDT)

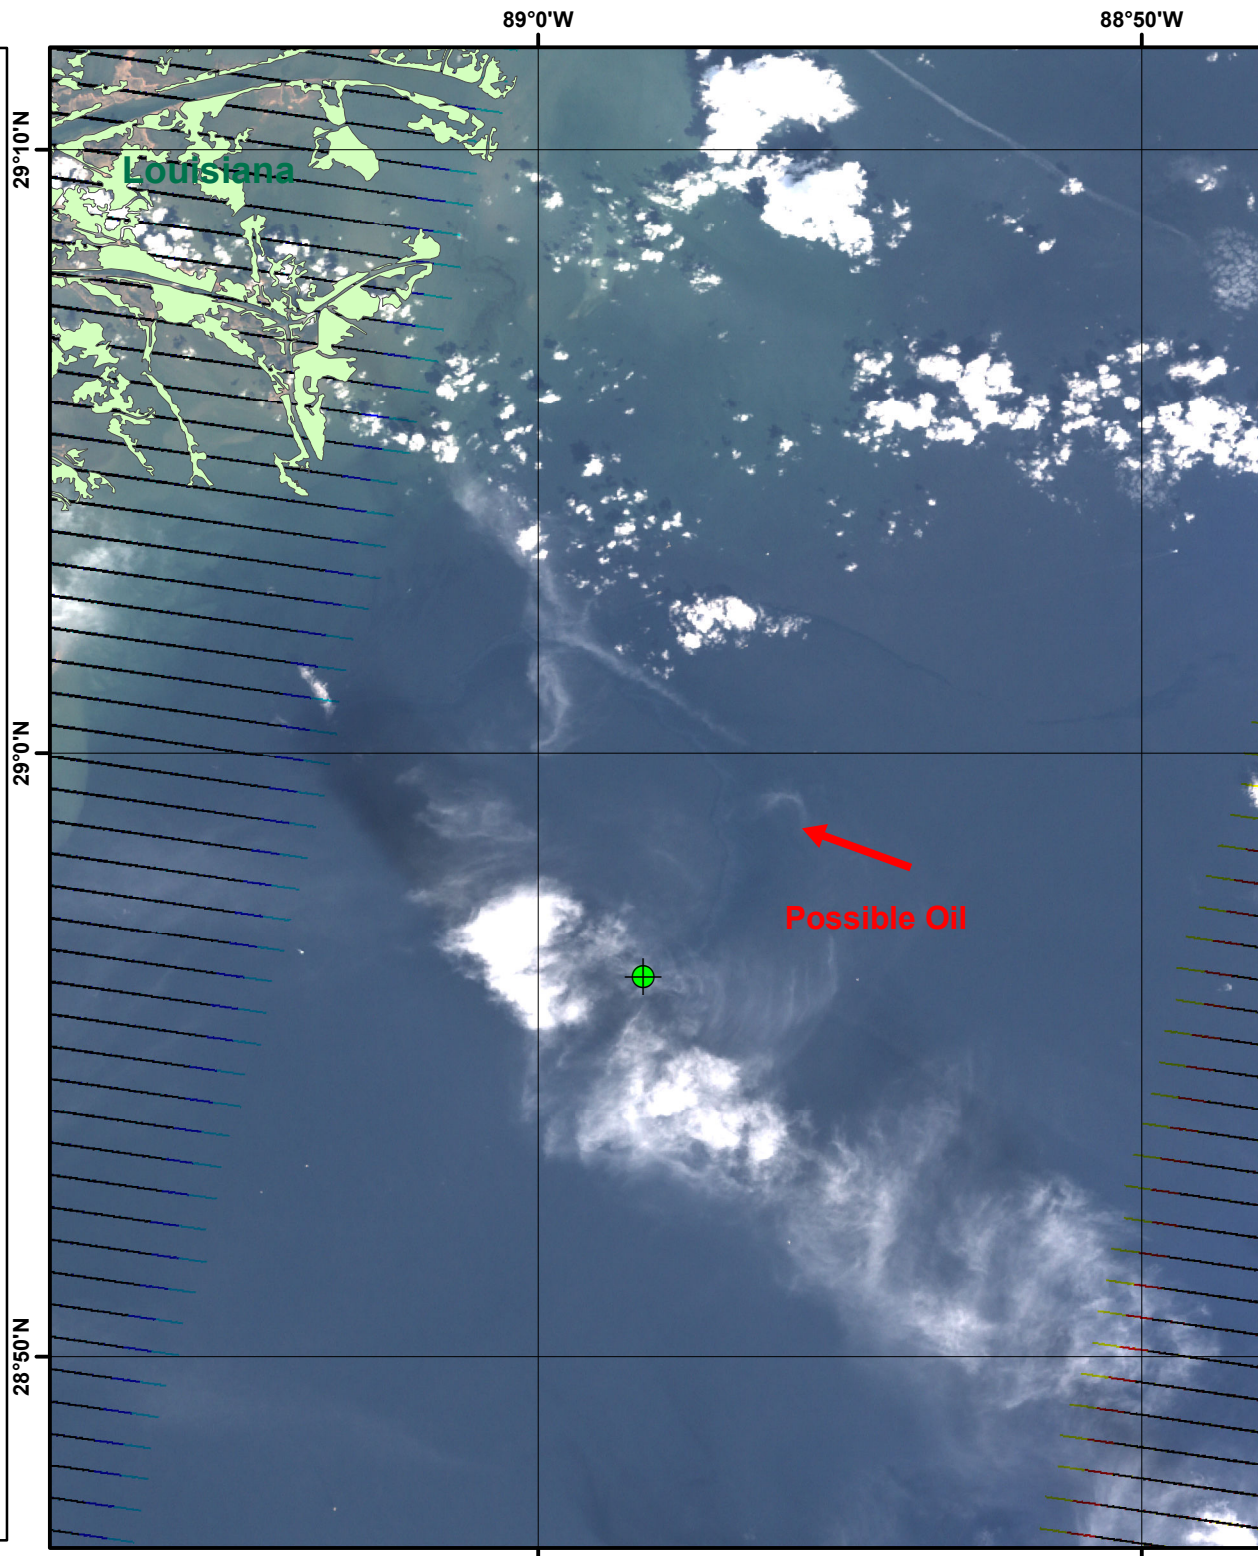
Destroyed Taylor Platform :
[28°56'9" N / 88°58'12" W]

An oil slick extended 7.2 mi north of the destroyed Taylor platform at 1622Z 27 September. The slick then extended both to the west and to the east such that it was 7.7 miles to the northeast of the platform at its eastern extent and 7.3 miles to the northwest of the platform at its western extent.

Winds at the time were from the southeast at 10 knots and the skies were partly cloudy.
