# MARINE POLLUTION SURVEILLANCE REPORT

REPORT DATE: AUGUST 9, 2012  
REPORT TIME: 2200Z (1700 CDT)  
ANALYST: VOGT

DATA SOURCE: SPOT-5  
MODE: MULTI-SPECTRAL  
RESOLUTION: 10 METERS  
IMAGE DATE/TIME: 8/09/2012 1626Z (1126 CDT)

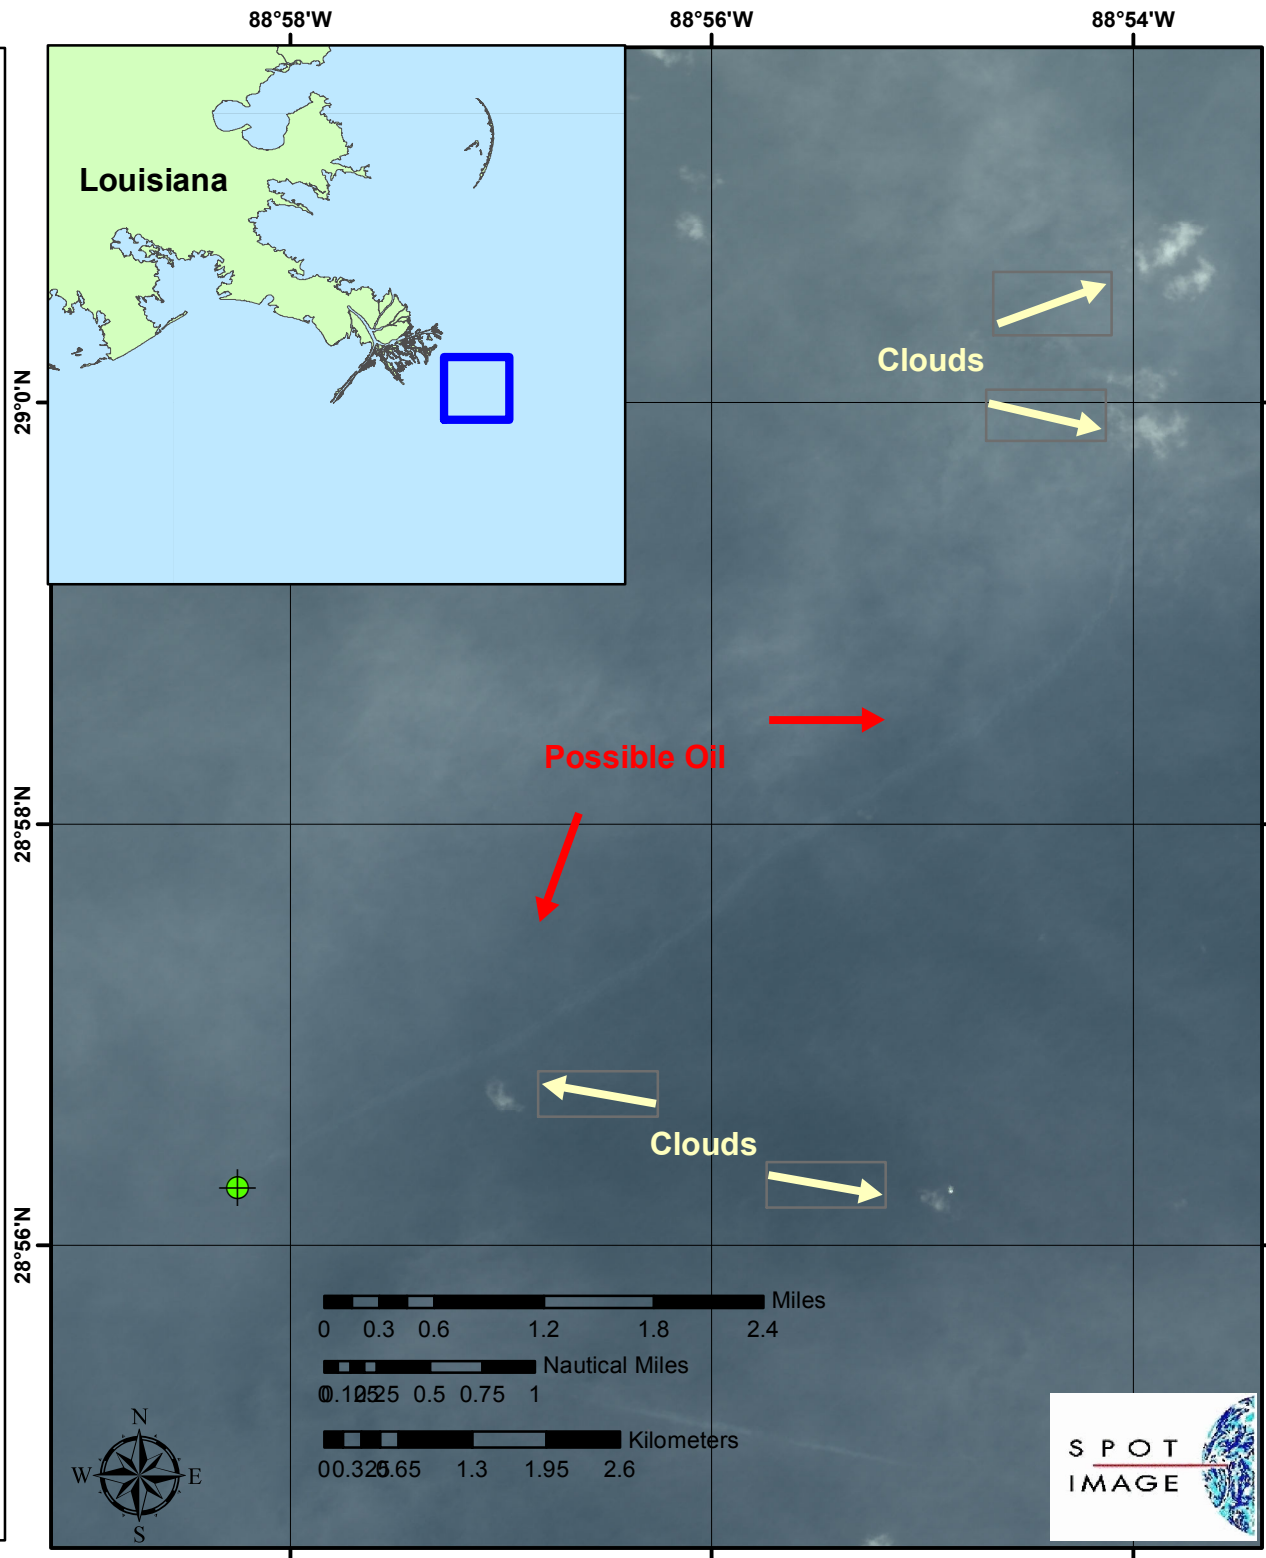
Destroyed Taylor Platform :  
[ 28°56'9" N / 88°58'12" W ]

A possible oil slick is present originating from the Destroyed Taylor Platform. This slick is approximately 5.8 miles long and only a mere 0.1 miles wide and extends to the northeast. There are thin cirrus clouds over the area but the slick still had a good contrast to its surroundings.
