# MARINE POLLUTION SURVEILLANCE REPORT

Analysis Provided by: The National Oceanic and  
Atmospheric Administration/National Environmental  
Satellite, Data and Information Service (NOAA/NESDIS)

REPORT DATE: JUNE 07, 2012  
REPORT TIME: 2145Z (1645 CDT)  
ANALYST: BELGE

DATA SOURCE: LANDSAT-7  
MODE: Multispectral  
RESOLUTION: 30 meter  
IMAGE DATE/TIME: 6/7/2012 1620Z (1120 CDT)

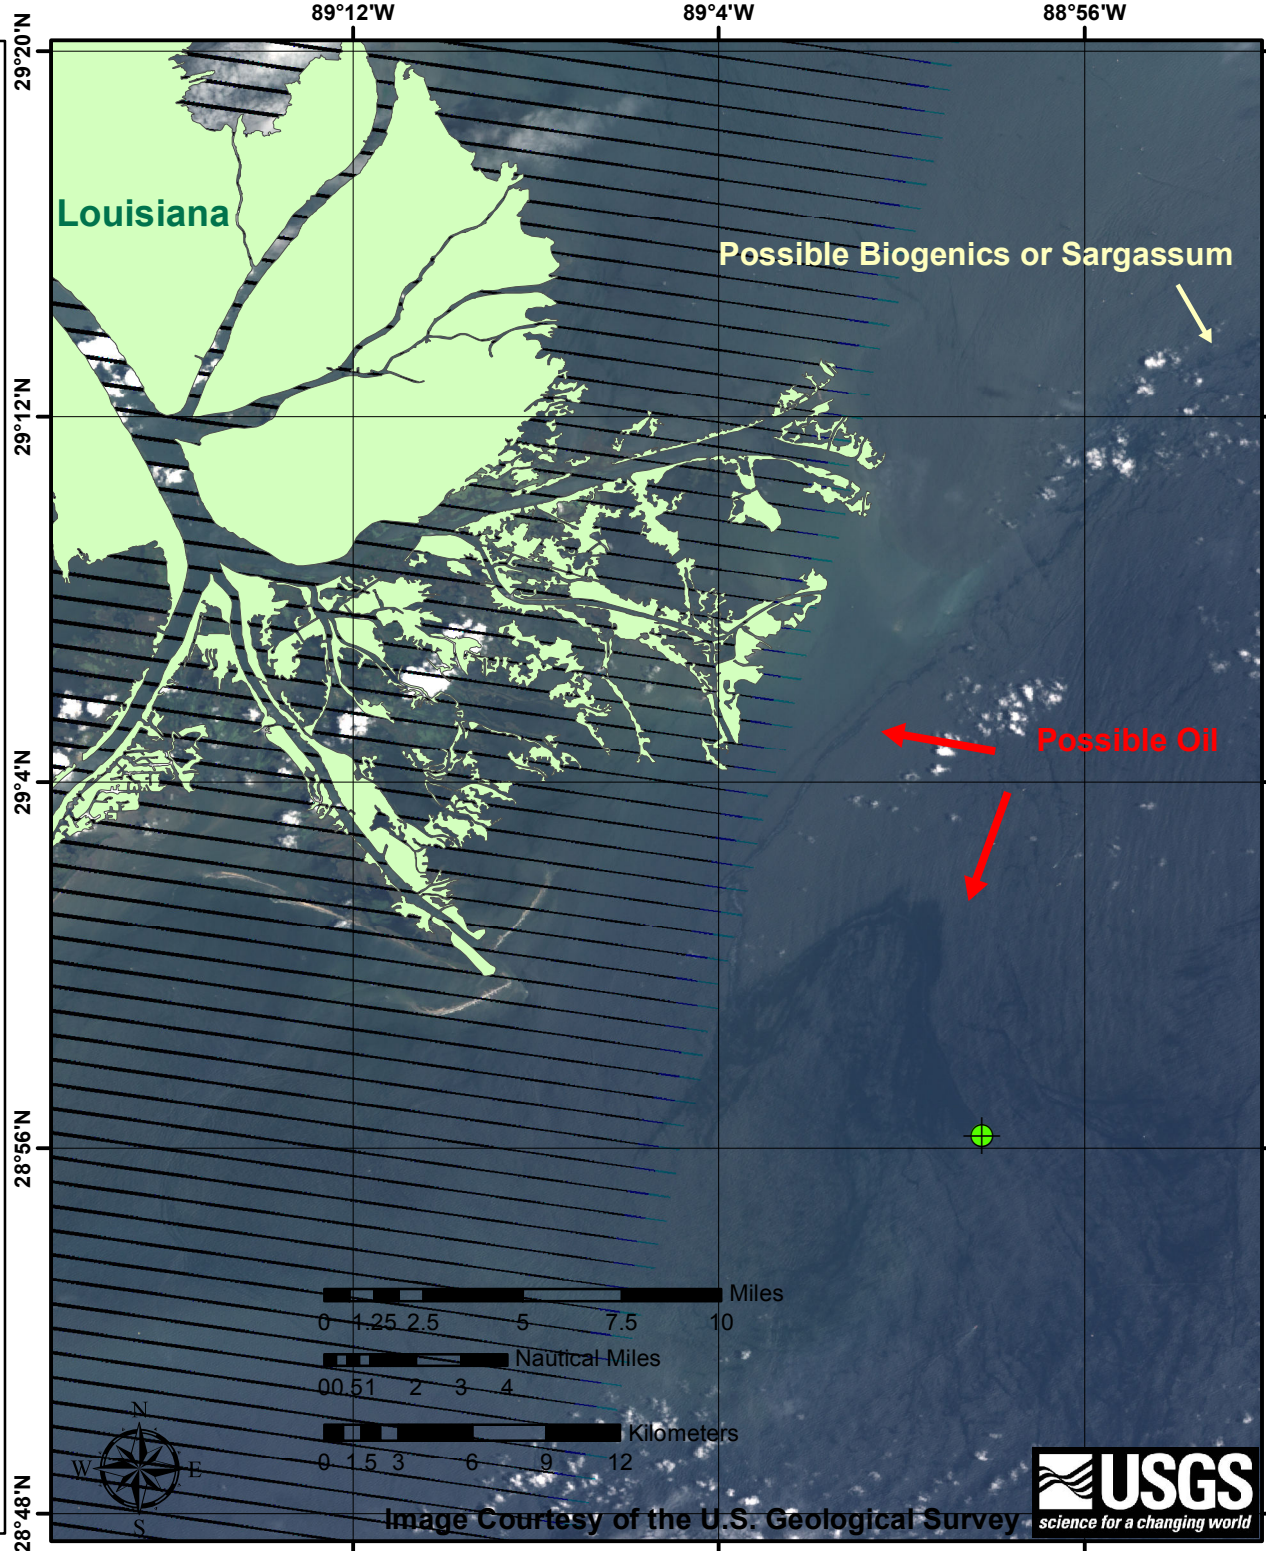
Destroyed Taylor Platform :  
[ 28°56'9" N / 88°58'12" W ]

An area of possible oil can be seen coming from the  
destroyed Taylor Platform this afternoon and moving  
towards the northwest. Relatively calm wind conditions  
were noted in this region at this time with a stationary  
boundary located just to the north. Also noted several  
areas of sargassum and biogenics in and around the  
Bird's Foot Delta in this image.
