# MARINE POLLUTION SURVEILLANCE REPORT

Analysis Provided by: The National Oceanic and  
Atmospheric Administration/National Environmental  
Satellite, Data and Information Service (NOAA/NESDIS)

REPORT DATE: JUNE 28, 2012  
REPORT TIME: 2145Z (1645 CDT)  
ANALYST: TURK

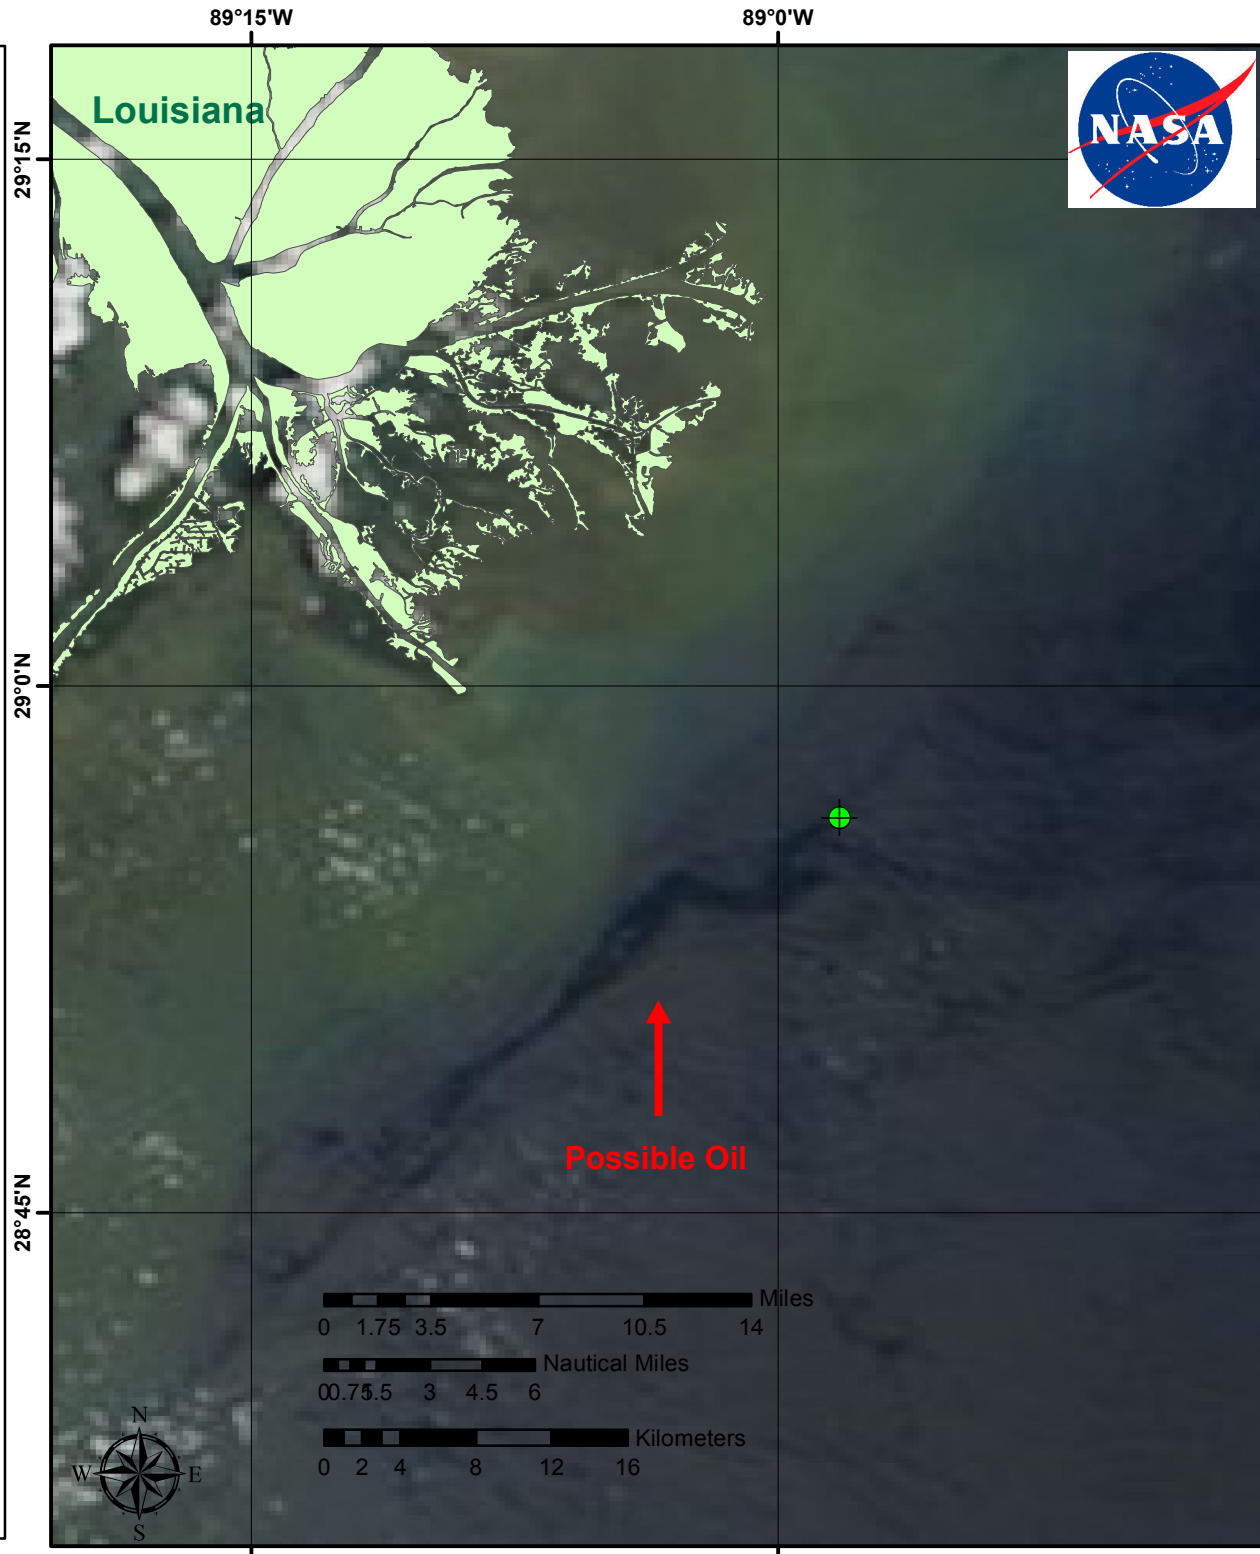
Destroyed Taylor Platform :  
[ 28°56'9" N / 88°58'12" W ]

A possible oil slick extended 15.6 miles to the southwest  
of the destroyed Taylor platform. Winds were light,  
blowing from the east at 5 knots, and sky conditions  
were mostly clear at the time of the image.
