# MARINE POLLUTION SURVEILLANCE REPORT

REPORT DATE: APRIL 28, 2012  
REPORT TIME: 2100Z (1600 CDT)  
ANALYST: WARREN

DATA SOURCE: AQUA MODIS  
MODE: Multispectral  
RESOLUTION: 250 meter  
IMAGE DATE/TIME: 4/28/2012 1905Z (1405 CDT)

Destroyed Taylor Platform :  
[ 28°56'9" N / 88°58'12" W ]

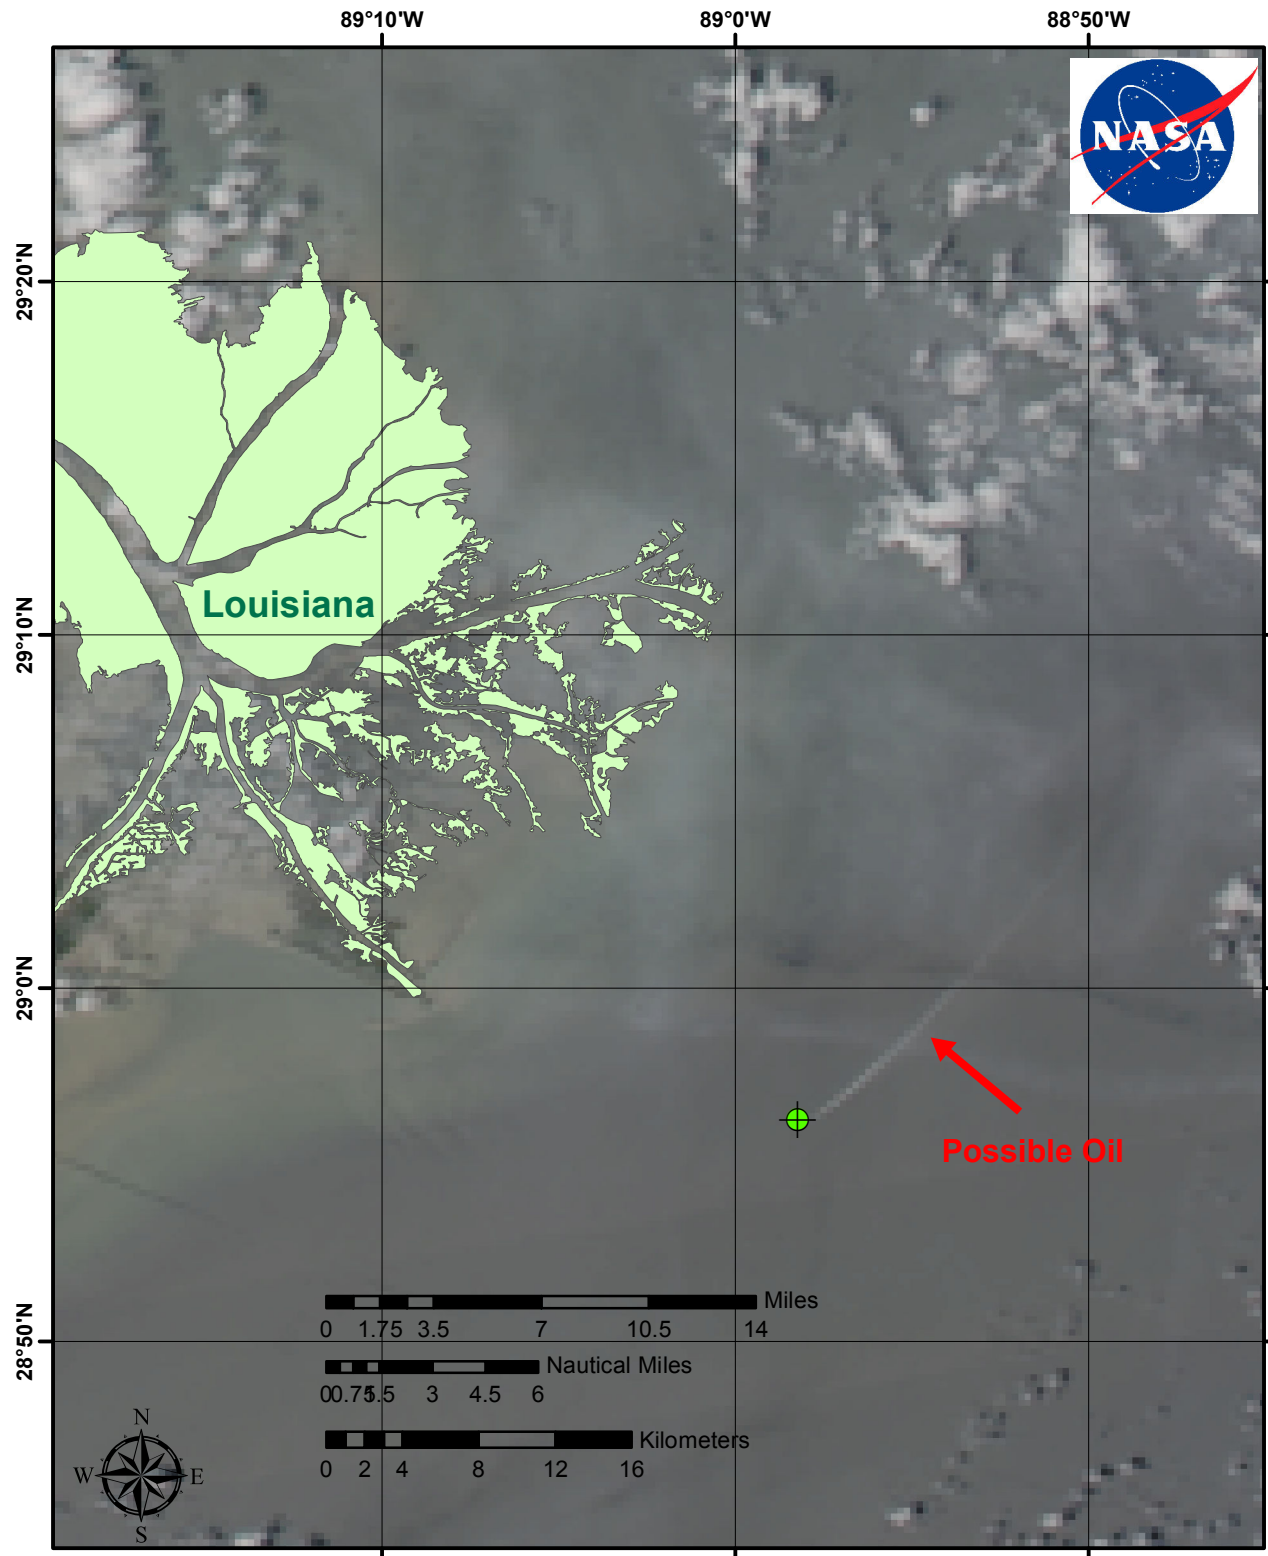
Possible oil slick seen extending 13 miles northeast from  
Destroyed Taylor platform. Orientation of anomaly from  
suspected point source is noted to be in good agreement  
with southerly low-level winds and southwest to  
northeast surface ocean current flow.
