MARINE POLLUTION SURVEILLANCE REPORT

Analysis Provided by: The National Oceanic and
Atmospheric Administration/National Environmental
Satellite, Data and Information Service (NOAA/NESDIS)

REPORT DATE: JANUARY 23, 2018
REPORT TIME: 2100Z (1500 CST)
ANALYST: WHISNANT

DATA SOURCE: LANDSAT-8 OLI
MODE: Multispectral
RESOLUTION: 30 meter
IMAGE DATE/TIME: 1/23/2018 1626Z (1026 CST)

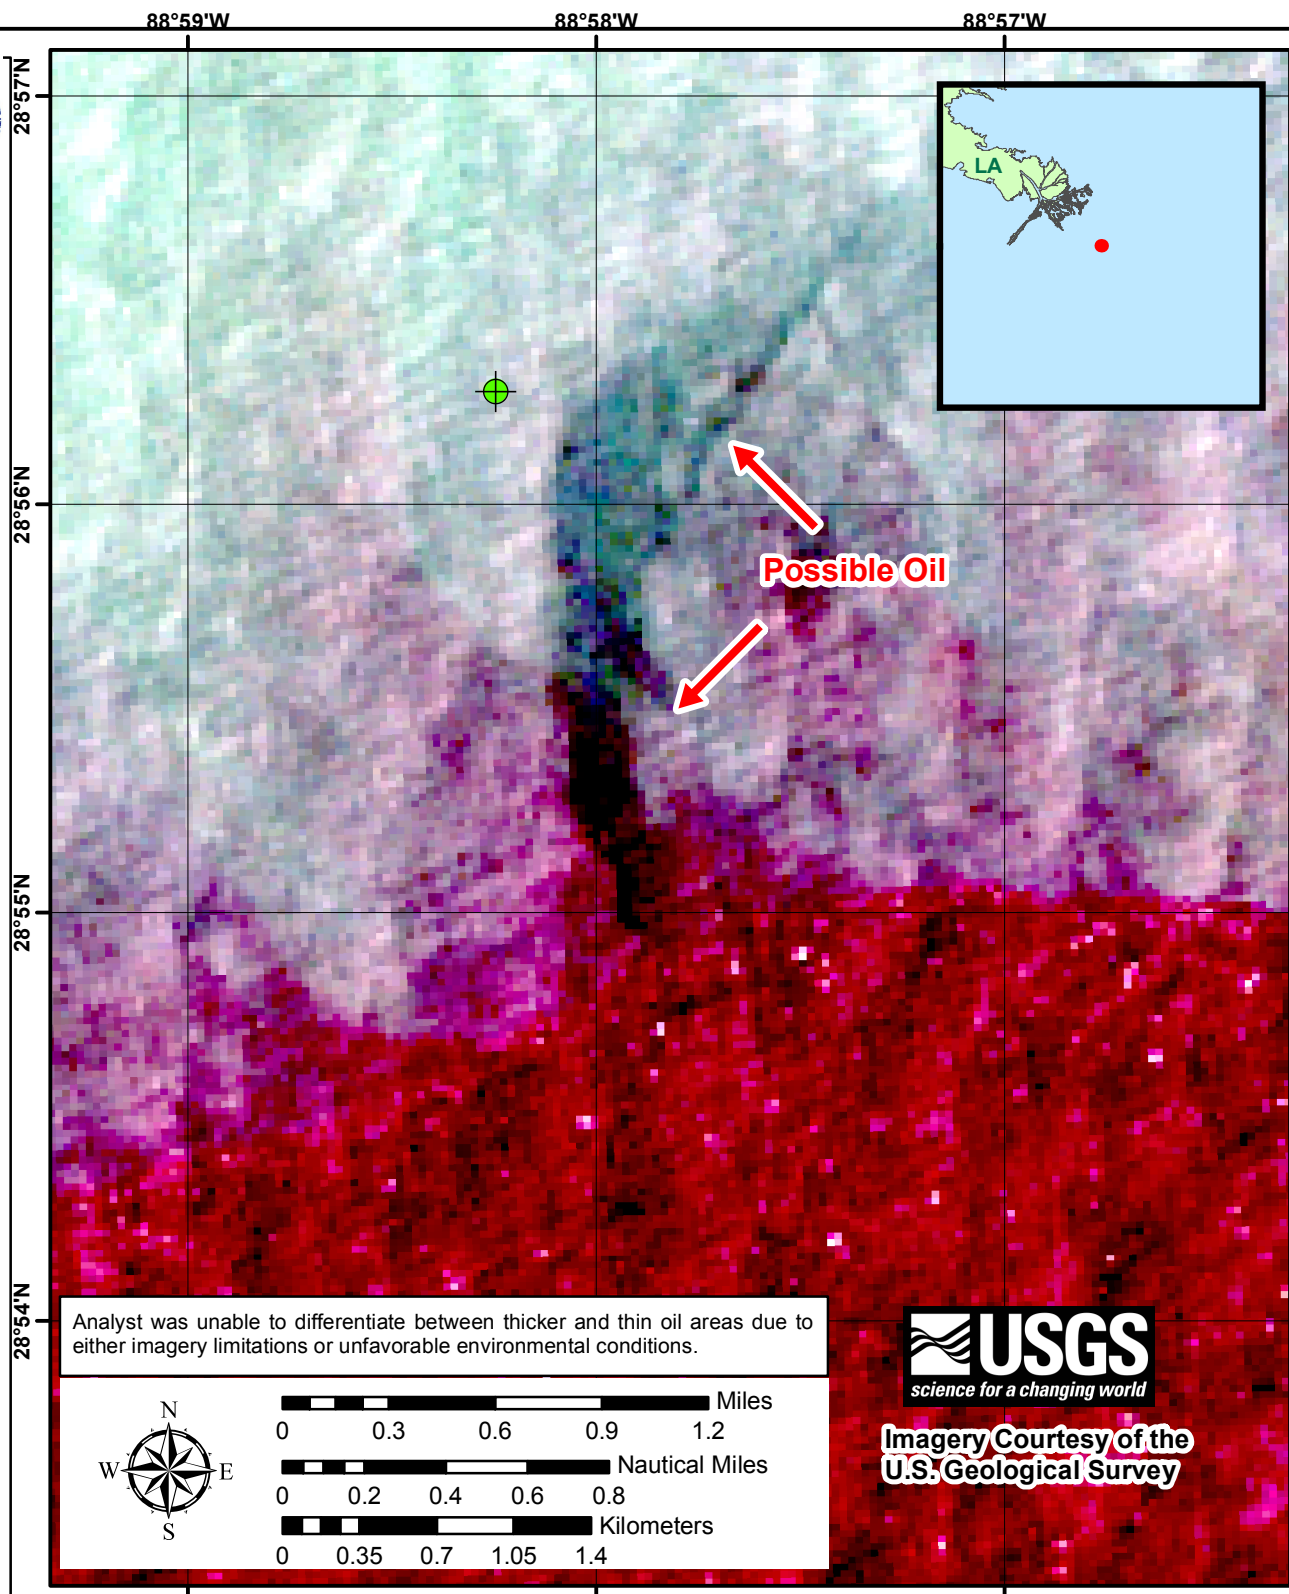
1.5 km² Area of Possible Oil

CONFIDENCE: Medium-High

Satellite imagery revealed an anomaly believed to be an oil slick in the vicinity of the Destroyed Taylor Platform. The anomaly showed mostly good contrast with its background and appeared out of place. The anomaly stretched a total of 1.95 nautical miles from its northernmost extent to its southernmost extent and had a maximum width of 0.46 nautical miles. Surface winds were out of the North at 10-15 knots around the of the image. Confidence is determined to be Medium-High given the anomaly is not directly attached to the repeat leak source and the northern extent showed lower contrast than the rest of the anomaly.
