# MARINE POLLUTION SURVEILLANCE REPORT

Analysis Provided by: The National Oceanic and  
Atmospheric Administration/National Environmental  
Satellite, Data and Information Service (NOAA/NESDIS)

REPORT DATE: May 20, 2011  
REPORT TIME: 2215Z (1715 CDT)  
ANALYST: Ruminski

DATA SOURCE: Landsat7  
MODE: Multispectral  
RESOLUTION: 30 meter  
IMAGE DATE/TIME: 5/20/2011 1619Z (5/20/11 1119 CDT)

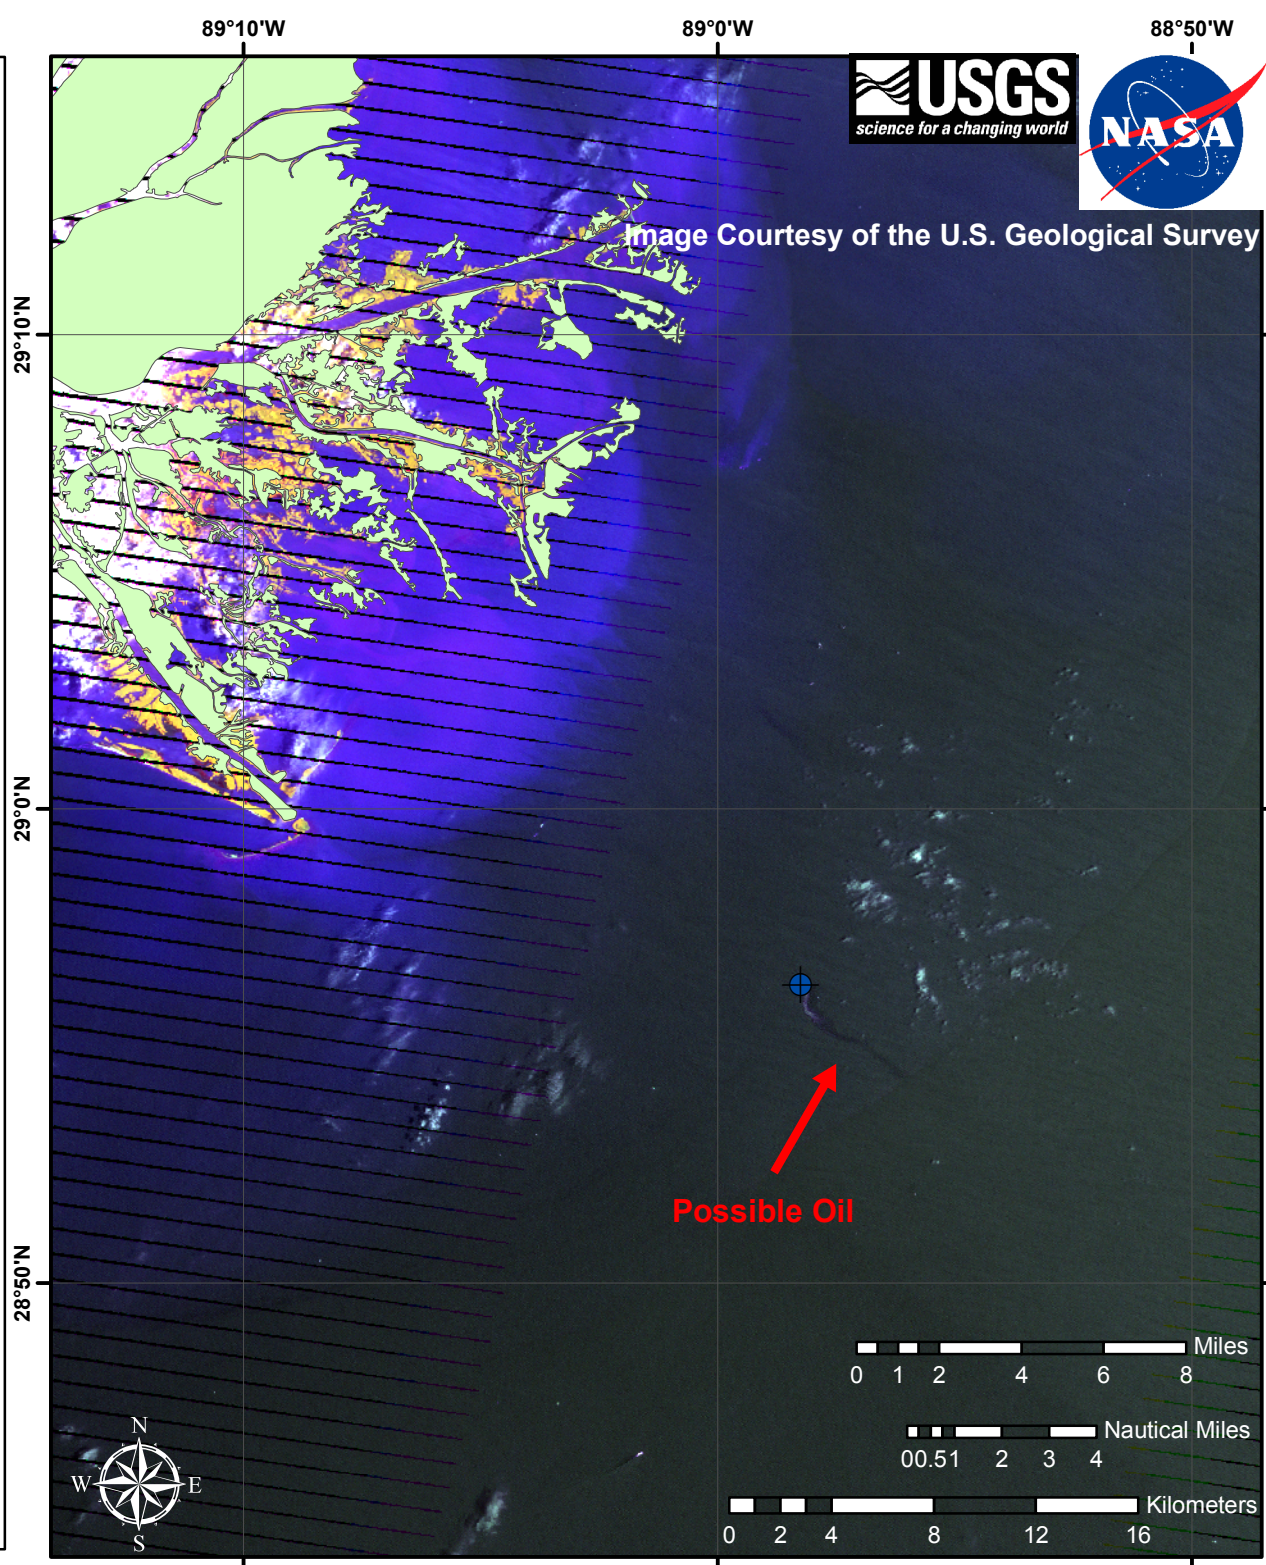
Destroyed Taylor Platform :  
[ 28°56'9" N / 88°58'12" W ]

Possible oil slick extends approximately 5 km to the  
southeast from the destroyed Taylor (Saratoga) platform  
at 28°56'9" N / 88°58'12" W. The slick averages about .5  
km in width.
