# MARINE POLLUTION SURVEILLANCE REPORT

Analysis Provided by: The National Oceanic and  
Atmospheric Administration/National Environmental  
Satellite, Data and Information Service (NOAA/NESDIS)

REPORT DATE: July 23, 2012  
REPORT TIME: 2045Z (1545 CDT)  
ANALYST: KIBLER

Destroyed Taylor Platform :  
[ 28°56'9" N / 88°58'12" W ]

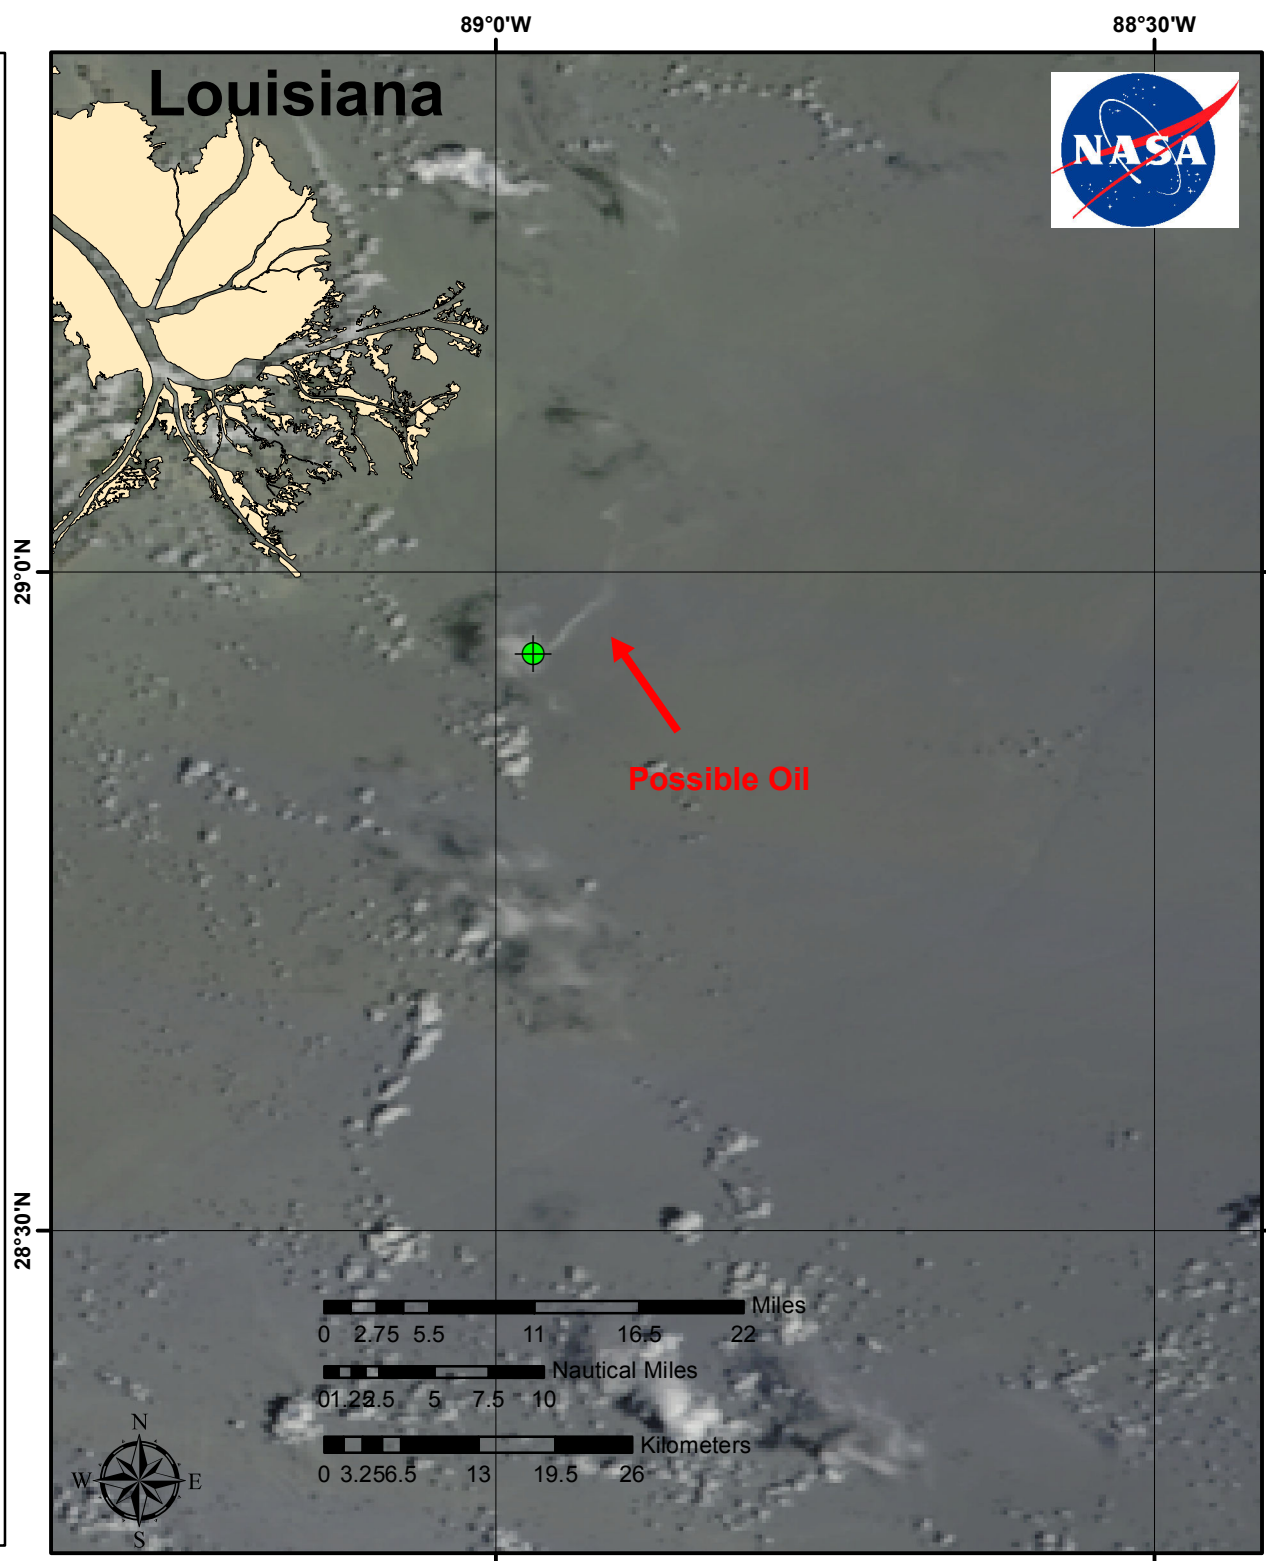
POSSIBLE OIL SLICK EXTENDING NEARLY 8 NM NNE  
FROM TAYLOR PLATFORM, A KNOWN LEAK  
SOURCE. CLOUDS ARE SOUTH AND WEST OF  
TAYLOR PLATFORM BUT A MOSTLY CLEAR VIEW TO  
THE NORTH AND EAST.
